MANTA

WORLD

The Virtual Newsletter for Manta Owners

No. 2 – 1 January 2000

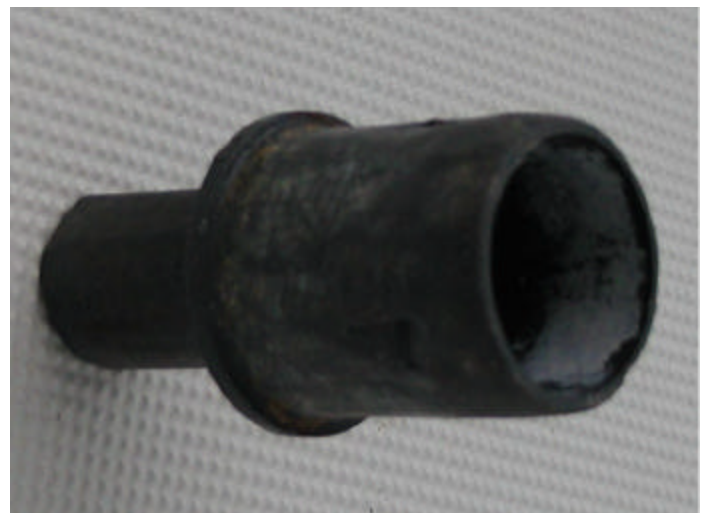
HEAD, FLUSH FASTER– Magic

This is the culprit. It impedes the flow where the 1" hose from the head pump connects to the 1-1/2" hose feeding into anti-siphon elbow. It reduces the ID from 1" to a 3/4", creating backpressure. To fix that, take the culprit out, slip a 2" long 1 1/2" OD thin wall plastic pipe (i.e. a piece of sink drain) over the end of the 1" hose for fit. Then glue it in place with 5200 and let it dry for 2 days. Now you can slip the end of the 1" hose into the 1 1/2" hose and clamp it as close to the anti-siphon as possible. Cut the 1 1/2" hose shorter, if possible. You will find that w/o the restriction the head flushes in 1/2 the time with 1/2 the water.

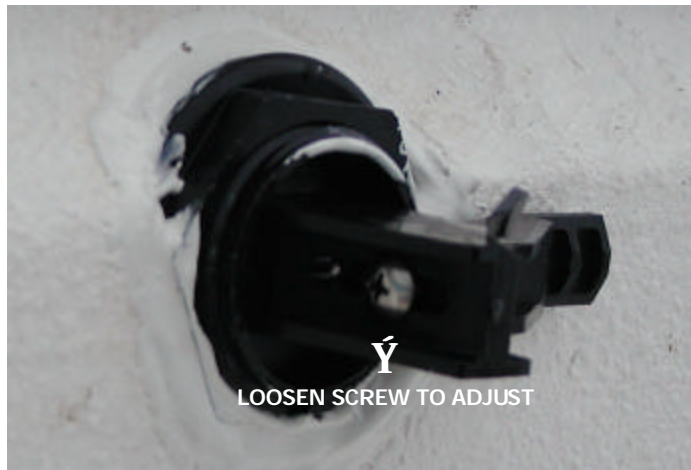
1. Tighten the lock bar that holds down the hatch, so that you have to step (put weight on) onto the hatch to open or close the lock. If your hatches open w/o putting weight on they are not tight enough.

2. Put silicon grease around the rotating part of the lock. It is not sealed at all. S/V Bobcat is experimenting with an o-ring to seal the cover against the lock.

Just about every Manta owner is complaining about water getting into the forward lockers and into the crash flotation compartments. The first problem may be insufficient pressure on the hatch rubber seal and the second is the definitely the unsealed lock.

If you still get water into the locker, tape up the latch with duct tape prior to passages or contact S/V Nauticat for special rubber seals.
